Proceedings of the 11th International Scientific Conference Rural Development 2023

Article DOI: <https://doi.org/10.15544/RD.2023.013>

THE RESEARCH ON THE TECHNICAL STATE OF RETAINING WALLS OF HYDRO SCHEMES IN THE JONAVA DISTRICT

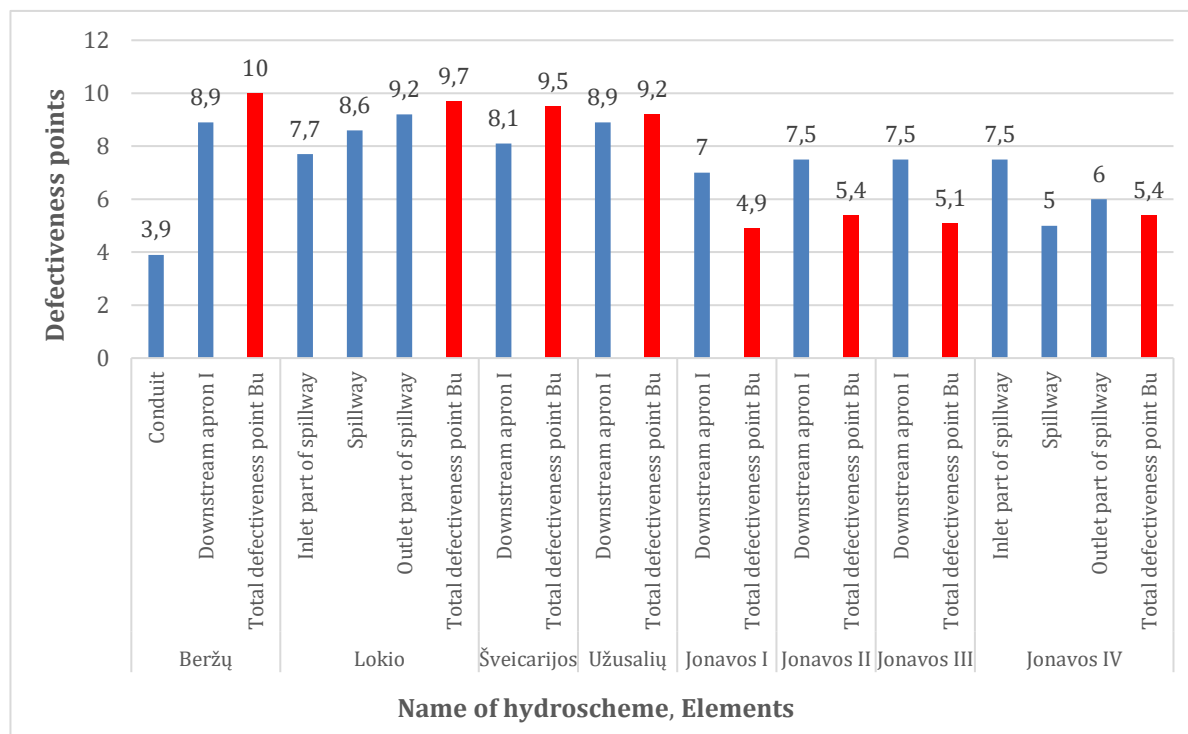
Fig. 1. Defectiveness score B_u for the individual structures of the downstream apron of the investigated hydro schemes and for the assessment of the overall technical state of the hydro scheme.

Based on the results of the investigations presented in Figure 1, the deterioration of the state of the flood spillway outlet structures (retaining walls) was found to be the most severe, with a score of up to 9.2 at the Lokys hydro scheme. Significant deterioration (8.9 points) was also recorded in the structures of the downstream apron of the other hydro schemes (Beržai and Užusaliai). According to the results of the investigations, the structures of the Šveicarija dam (8.1 points) and Jonava city dams I–III (7.5 points) are the closest to the critical limit of 8.1 defectiveness score (characterising very poor condition).

The overall assessment score B_u for the technical state of the hydro schemes of Beržai, Lokys, Šveicarija and Užusaliai ponds in the Jonava district is 9.2 to 10.0. According to STR 1.07.03:2017 “Procedures for technical and operational supervision of structures. Procedure for formation of new real estate cadastre objects” point 81.3, if the overall score of the technical state of the hydro scheme is between 8.1 and 10.0, its state is assessed as very bad (emergency), i.e., there are significant defects in the element that make its further operation impossible, and the collapse of the entire structure is possible.

The overall assessment score B_u for the technical state of the hydro schemes of the Jonava city ponds I–IV is 4.9 to 5.4. According to STR 1.07.03:2017 “Procedures for technical and operational supervision of structures. Procedure for formation of new real estate cadastre objects” point 81.3, if the overall score of the technical state of the hydro scheme is between 4.1 and 6.0, its state is assessed as satisfactory, i.e., there are defects in the element that have a negligible impact on its strength, reliability, and durability.

According to the results of the technical state assessment (carried out per STR 1.07.03:2017), reconstruction works are necessary for the Beržai, Lokys, Šveicarija and Užusaliai hydro schemes in the Jonava district, and repair works are necessary to eliminate defects and damage in the hydro schemes of the Jonava city ponds I–IV.

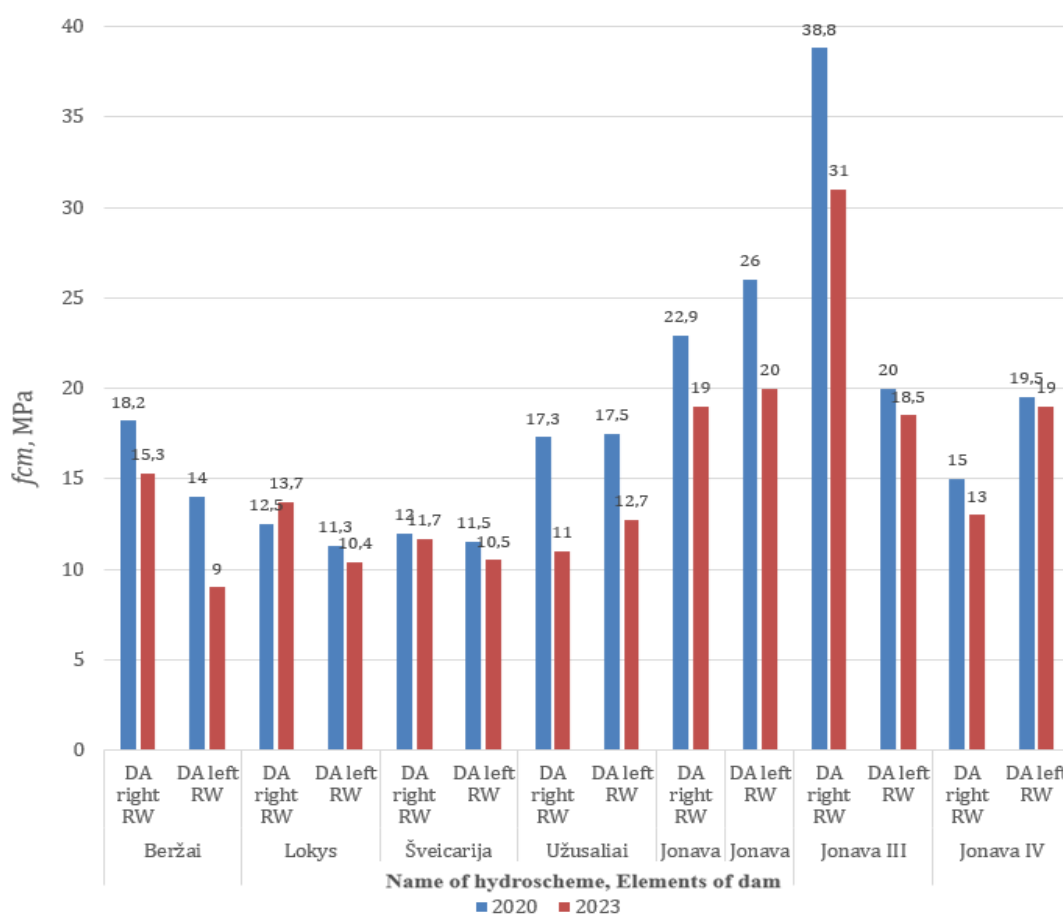
Fig. 2. Results of strength tests on the retaining walls of the DA of hydro schemes.

Based on the results of the investigations presented in Figure 2, we found that:

In 2023, the highest minimum compressive strength of concrete is found in the Jonava city hydro scheme IV, which is 38.8 MPa and corresponds to concrete class C35/45. The lowest minimum compressive concrete strength is 9 MPa and it was found in the Beržai hydro scheme (Jonava district), corresponding to concrete class C 8/10.

According to the current standard LST EN 13791:2019 for structures subjected to moderately humid and cyclically wet and dry environments during use and Table 1 of STR 2.05.05:2005 (Annex 3), the recommended minimum compressive strength class of concrete is C30/37. Based on the research data, it was found that only the concrete strength of the reinforced concrete structures of the retaining walls on the right side of the Varnaka River in the Jonava city III pond is higher than the recommended strength and the compressive strength class of the structures meets the requirements, while the concrete of the retaining walls of the downstream apron of the other hydro schemes investigated does not comply with the current requirements.
