MAIN DEFECTS AND DETERIORATIONS OF REINFORCED CONCRETE STRUCTURES IN THE ABANDONED HYDRAULIC STRUCTURES OF LITHUANIA

Aim of research: To investigate and to evaluate the technical state of the abandoned hydraulic structures by identifying and assessing the major defects and damage, by forecasting the damage development and the impact on structure safety.

Object of research: The investigated abandoned hydraulic structures are in the territory of Lithuania, the main attention is focused on Klaipėda, Kaunas, Tauragė, Šiauliai, Utena, Panevėžys counties. 17 abandoned hydroschemes in Raseiniai distr. Kaunas county were chosen for a more detailed investigations: Juteikiai, Tauručiai, Verėduvaitė, Paturkšlys, Betygala, Pramedžiava, Girkalnis I, Girkalnis II, Kaulakiai II, Dumšiškiai, Piktaičiai, Gyliai I, Gyliai II, Vėjukai, Viduklė, Paviduklė, Vailabai. In this paper, the investigation results of technical state evaluation of 4 typical abandoned hydroschemes from Raseiniai distr. Kaunas county are presented.

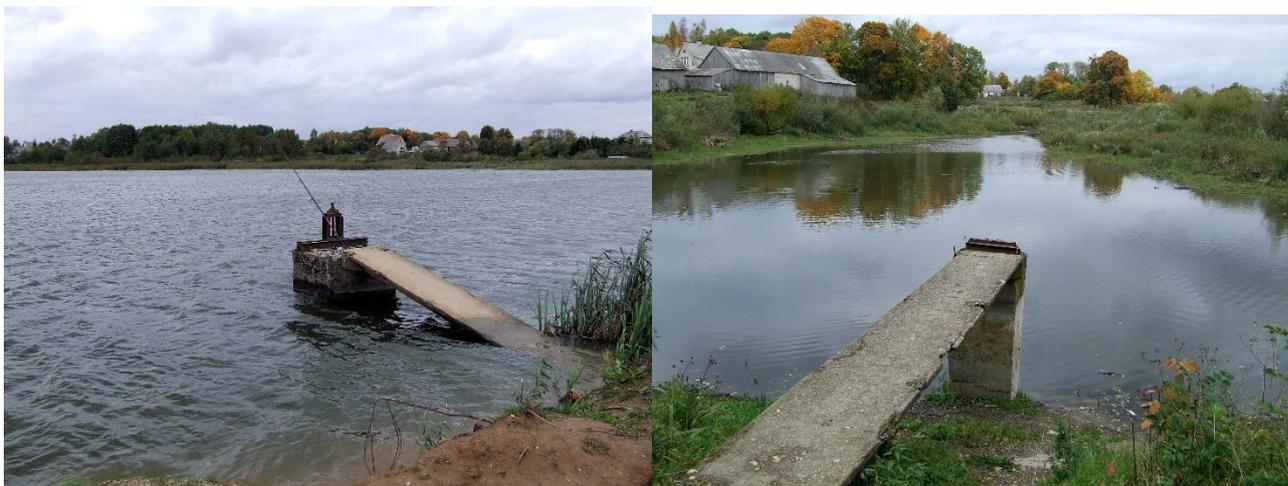
Figure 3. The shaft culverts in Gyliai I and Gyliai II abandoned hydroschemes

According to the results of testing of the concrete compression strength (performed by non-destructive test method), it was established that the characteristic compression strength $f_{ck,cub}$ of reinforced concrete shaft culvert is bigger in the part above the designed water level by 146 to 273 % in comparison with the part under the designed water level (Table 1). These parts of weak concrete (corrosion of concrete can be seen in more light color of concrete and the deteriorations are under the designed water level) are visible seen in figures 3 and 4.

The broken corners, edges, the deteriorated concrete covering layer, the stratified concrete, cracks, bad concrete pouring and steel corrosion, the deformations of service bridges and shaft culverts are presented in figures 3 and 4. The propagation of noticed dangerous defects and deteriorations could lead to the collapse of shaft culverts that are attributed to the category of main structures of a hydroscheme.

According to the results of technical state investigation of abandoned hydroschemes in Raseiniai distr., the main defects and deteriorations of reinforced concrete structures are: bigger horizontal and vertical cracks; deformations; tilt in shaft; scour; deterioration, delamination, disintegration and cracking of concrete cover layer; collapsing of junctures; corrosion of reinforcement and concrete. Similar results were obtained by lithuanian (Šadzevičius et al, 2009; Šadzevičius, Mikuckis, 2010; Šadzevičius et al, 2011; Šadzevičius, Sankauskienė, 2013; Šadzevičius et al, 2013) and norwegian (Jensen 2001) researchers.

2. The shaft culverts in Gyliai I, Gyliai II, Gyliai III abandoned hydroschemes could be reconstructed using bigger diameter corrugated metal pipes. These reconstruction principles and possibilities could be applied in the reconstruction of abandoned hydraulic structures in Lithuania.
