COMPARATIVE ANALYSIS OF TWO STEEL GRADES 41CR4 AND P355NL1 FOR WINTER OPERATING CONDITIONS

Keywords: steel, impact strength, toughness, metallographic analysis.

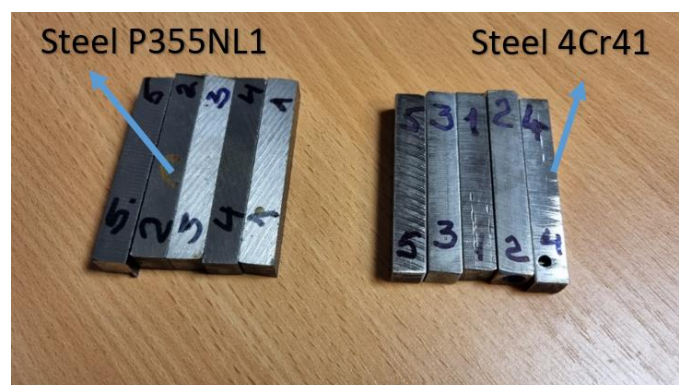
In the RTU laboratory, tests were carried out to determine impact strength and toughness, metallographic and chemical analysis of two steel grades are shown on Figure 2:

1. Steel grade 41Cr4;
2. Steel grade P355NL1.

For testing, 10 samples 55 mm long with 10 x 10 mm facets were prepared. The impact strength was tested in the RTU laboratory at an ambient temperature of +4,5 to +6,3 °C. This temperature regime corresponds to the autumn-winter season of operation.

Figure 2. Samples for research

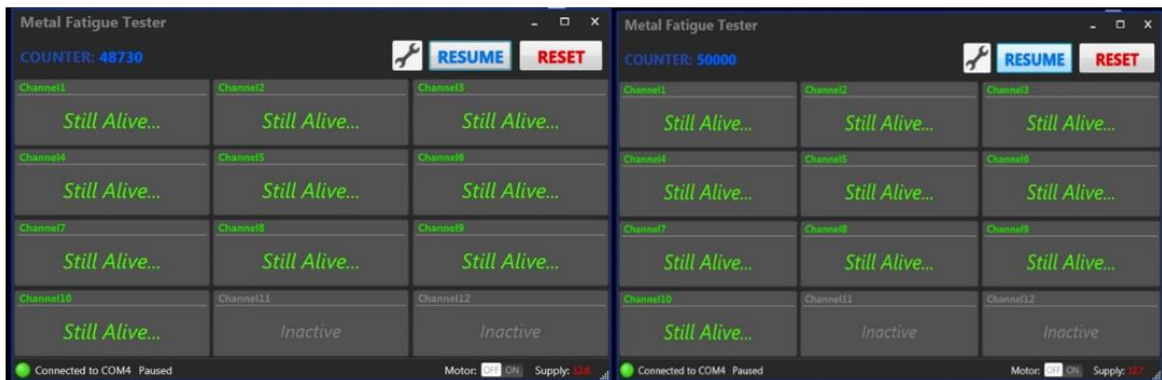
When testing for impact strength, the test results were processed by the computer program "Metal Fatigue Testop". As a result of the tests, no destruction of the samples was stated. The results of the impact strength are shown on Figure. 4.

Figure 4. Impact test data

Based on the test results, it was stated that all samples passed the impact strength test. After the impact strength test, the bolts were subjected to toughness tests. The purpose of the study is to compare the toughness parameters at three different temperature conditions -20°C; 0°C; +20°C. Sample cooling -20°C; 0°C was carried out in a refrigeration unit by direct cooling to the required temperature -20°C; 0°C. The cooling temperature was measured using a thermometer with an accuracy class of $\pm 0.1^{\circ}\text{C}$. Test data are presented in Table 2.
